Manhole Inspection Summary

Manhole # S57AA_003MH

Insp Date: **11/5/08 2:38 PM**

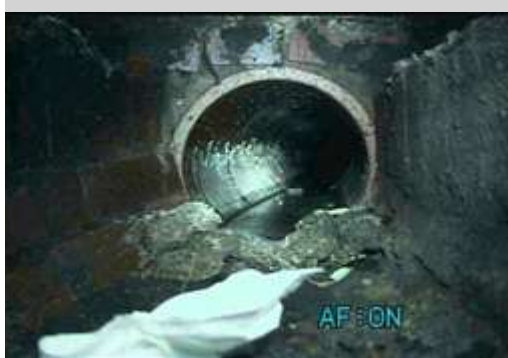
Channel Exposure: **Fully Open** Junc Dist: **0** nearest .5 ft. Azimuth: **0**

Condition: ☒ Sound ☐ Cracked ☐ Root Intrusion ☐ Deteriorated ☐ Leaks ☐ Debris

channel debris

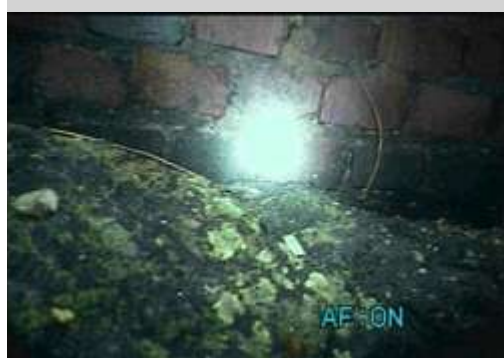
Defect 4

Condition: ☐ Sound ☐ Cracked ☐ Root Intrusion ☐ Deteriorated ☐ Leaks ☒ **Debris**

bench debris

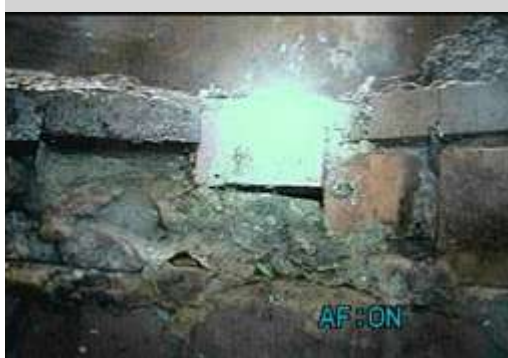
Defect 3

Chimney / Frame Adjustment ☒ Exists Material: **Brick and Concrete** ☐ Parged Height: **6** (in.)

Condition: ☐ Sound ☒ **Cracked** ☐ Root Intrusion ☒ **Loose Brick** ☒ **Deteriorated**

loose bricks, cracked and deteriorating chimney/frame adj

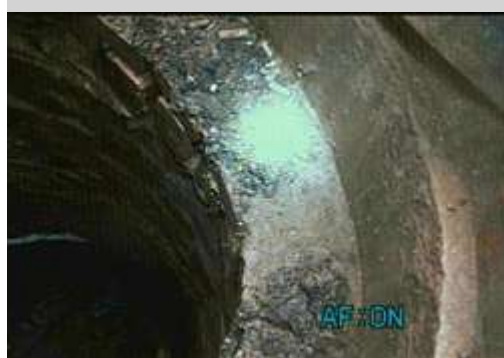
Defect 2

Frame Offset: **4** (in.) Condition: ☒ Sound ☐ Cracked ☐ Leaks

frame offset, loose bricks

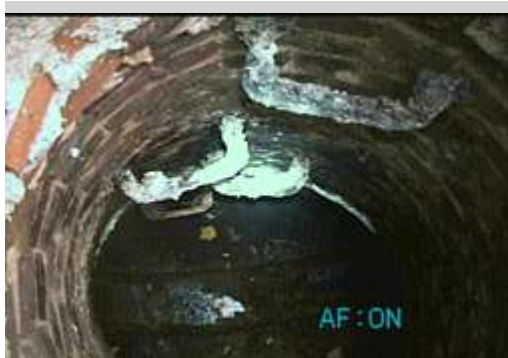
Defect 1

Steps Count: **4** Missing: **0** ☒ **Corroded**

cor. steps

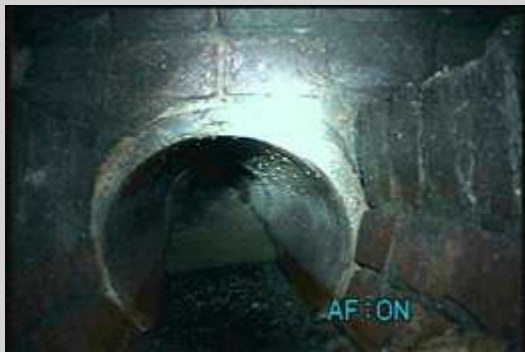
12 O'Clock Outflow

10 in. Circular Gravity Sewer
Pipe Out @ 12 O'Clock

Pipe Material: **Clay** ☐ Pipe Lined

Invert Depth: **9.00** (ft.) Flow Characteristics: **None**

Deposits: ☒ None ☐ Mud ☐ Sludge ☐ Debris ☐ Grease

Infiltration: **None** Pipe Seal Cond: **Unknown**

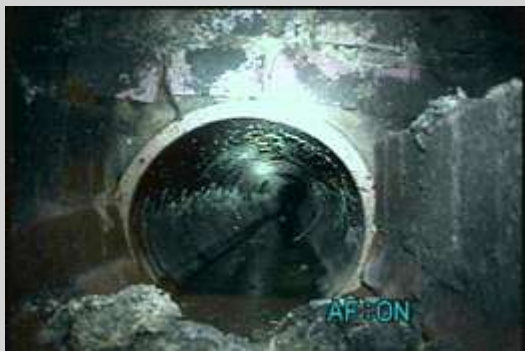
6 O'Clock Inflow

10 in. Circular Gravity Sewer
Pipe In @ 6 O'Clock

Pipe Material: **Clay** ☐ Pipe Lined

Invert Depth: **8.80** (ft.) Flow Characteristics: **None**

Deposits: ☒ None ☐ Mud ☐ Sludge ☐ Debris ☐ Grease

Infiltration: **None** Pipe Seal Cond: **Unknown**
